PASSAIC RIVER BASIN

HALEDON RESERVOIR

PHASE I INSPECTION REPORT NATIONAL DAM SAFETY PROGRAM

NJ 00021

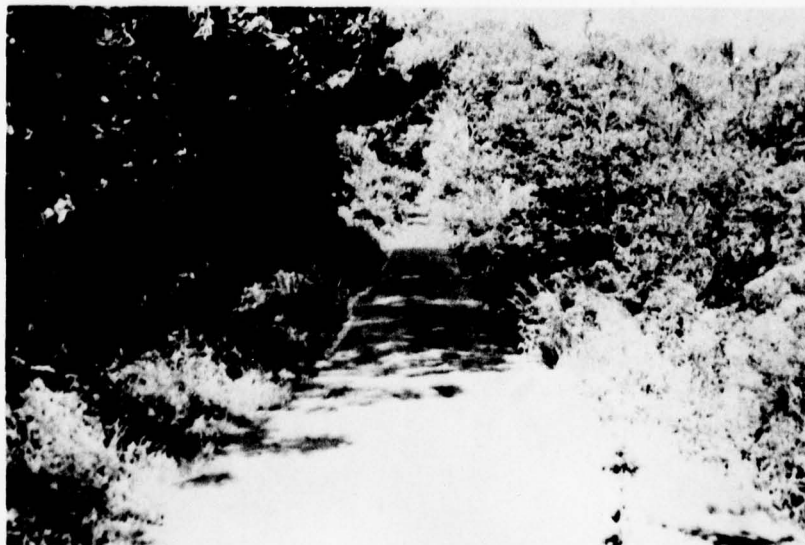
Photo 2 - View of crest of dam from left abutment.

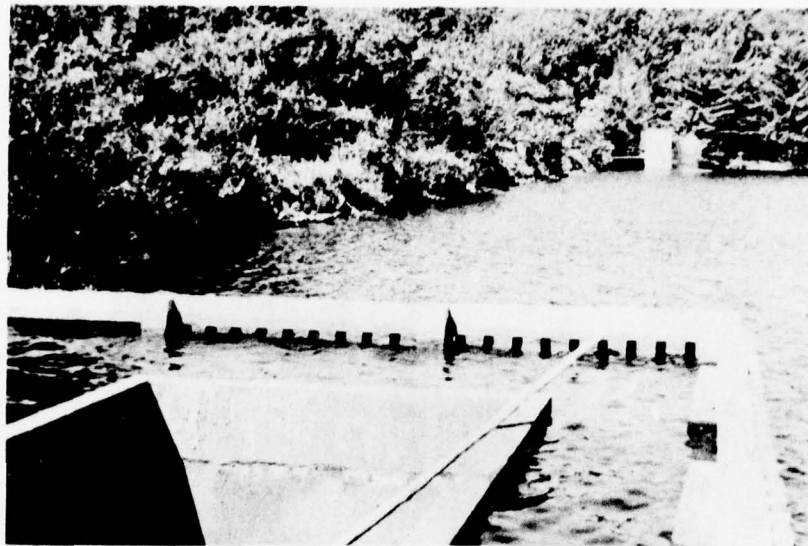
Photo 3 - Upstream slope of dam showing brush and vine overgrowth. Note thin log which is stuck in inlet.

1. All brush and trees should be removed from the downstream slope to avoid problems which may develop from their roots. The embankment should then be seeded to develop a growth of grass for surface erosion protection.
2. A program should be developed to monitor possible seepage through the embankment.
3. The erosion which has occurred on the upstream crest of the embankment should be repaired. An effective method of protecting the embankment from future erosion should be implemented.

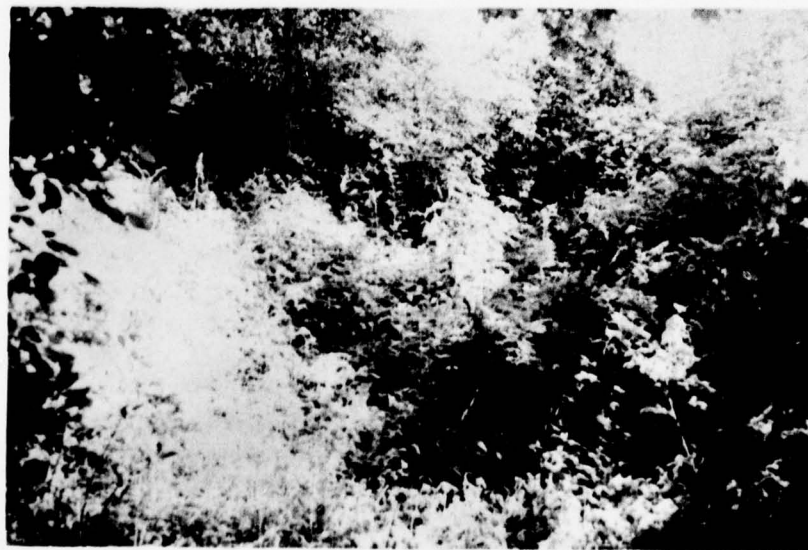
VISUAL EXAMINATION OF	OBSERVATIONS	REMARKS OR RECOMMENDATIONS
TREES	Large trees with 6 to 8 inch diameter trunks growing on downstream slope of embankment.	Trees should be cut and downstream slope kept clear of trees to prevent large root systems from penetrating embankment.
JUNCTION OF EMBANKMENT AND ABUTMENT, SPILLWAY AND DAM	Both abutments look good. No evidence of erosion can be found.	
ANY NOTICEABLE SEEPAGE	Some wet and/or seep areas noticed along toe but no flowing water could be found. Standing water found in one place approximately 50 feet right of spillway outlet.	Inspect area below dam monthly to detect changes in wet areas.
STAFF AND GAGE RECORDER	None at time of inspection.	Reinstall staff gage.
DRAINS	None.

Photo 4 - View of downstream slope of dam showing heavy brush and timber growth on embankment.

(1) All brush and trees should be removed from the downstream slope and the area seeded to develop a growth of grass for surface erosion protection.

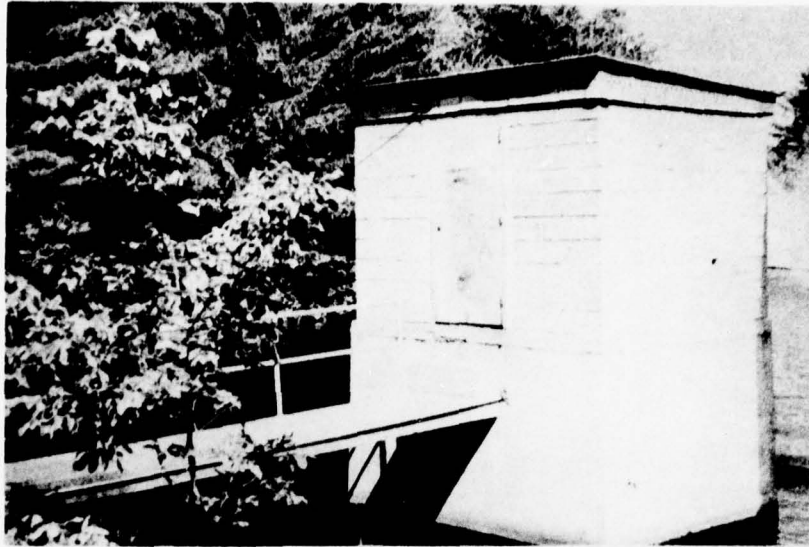
Only the upper few feet of the concrete intake tower and the covering concrete block building were visible to inspect. The structural concrete and block masonry appears in good condition. The control gates and raw water supply line could not be inspected. The four slide gates located in the outlet gate house are all functional and appear to be well maintained and in very good condition.

Photo 5 - Intake gate house for water supply to treatment plant.

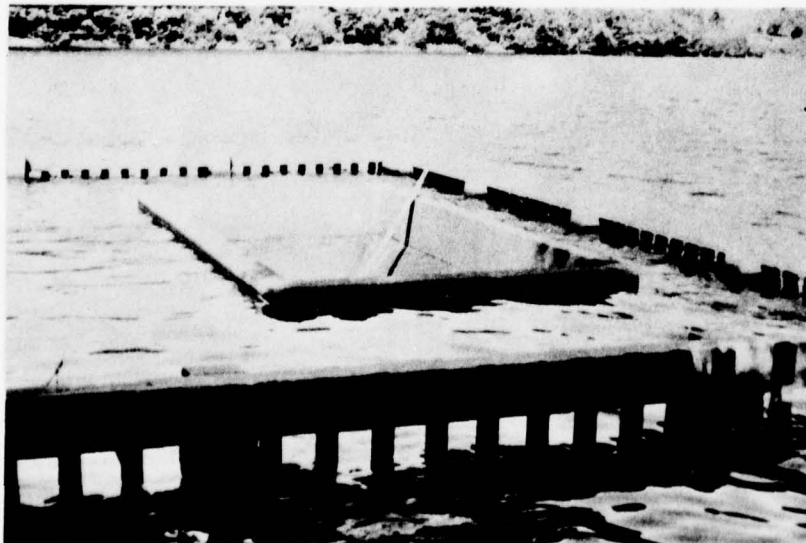
VISUAL EXAMINATION OF	OBSERVATIONS	REMARKS OR RECOMMENDATIONS
CONCRETE WEIR	Rectangular perimeter overflow wier wall with 8" wide flat top. Concrete surfaces in excellent condition. No structural cracks visible. Outer concrete trash rack structure installed about 8 years ago. Spillway is drop inlet type. Spillway discharge is carried through three conduits.	Minor seeps through joints around drop structure can be seen. No repair believed required.
APPROACH CHANNEL	None - Spillway inlet is out in the reservoir with approach from all around.	
DISCHARGE CHANNEL	Outlet of conduits is out of concrete headwall structure. Concrete headwall is in excellent condition. Downstream channel is a natural, rocky channel with gentle sideslopes.	
BRIDGE AND PIERS	None.	
CONCRETE PIPE CONDUITS	Three concrete pipe conduits carry spillway flow under embankment. All pipes are leaking through joints near axis of dam between 2-5 gpm. Large leak of about 20 gpm flow into drop structure around the left pipe. All flows are clear water. Concrete surfaces of pipe are in good condition.	Leakages around left pipe into drop structure into pipes at joints should be stopped.

Photo 6 - Rectangular drop-inlet spillway intake and concrete trash guard.

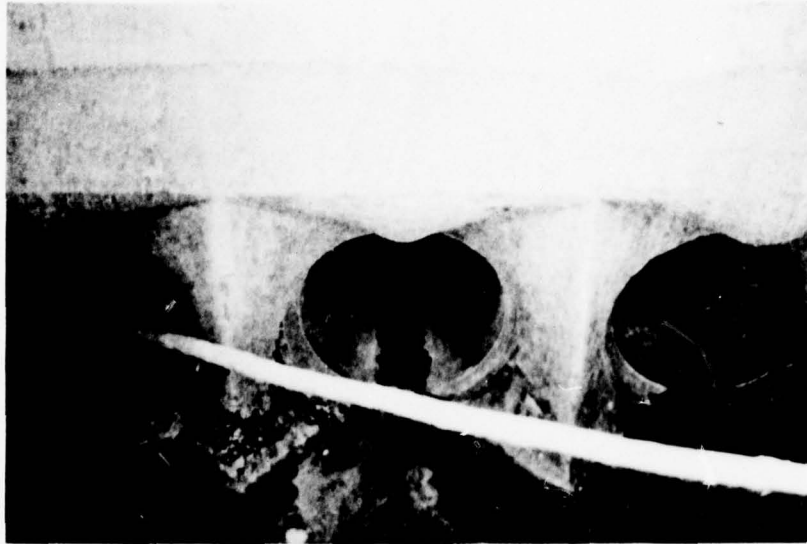
The concrete drop inlet structure and surrounding concrete trashrack are in excellent condition. No evidence of structural cracking or spalling could be found. Most of the joints in the precast concrete pipe conduits are leaking small quantities of clear water all

around the pipe. The joint between the outside of the left conduit and the drop inlet wall was leaking several gallons per minute of clear water.

Photo 7 - Three 42-inch diameter concrete pipe conduits in spillway drop-inlet structure. Note thin log resting across outlets.

The repairs to stop spillway conduit leakages should be undertaken within three months.

The conduit leakages can be stopped best by pressure grouting in the earth embankment behind the joints through holes drilled in the concrete.

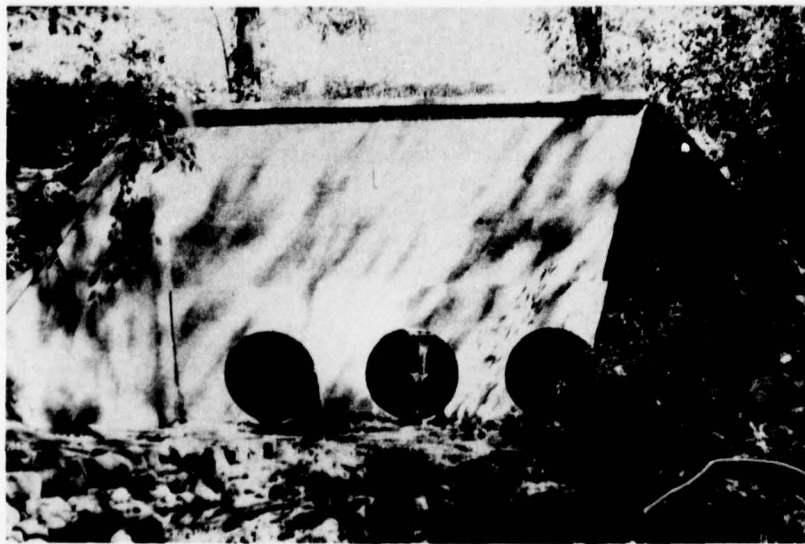
Photo 8 - View of spillway outlet conduits and headwall.

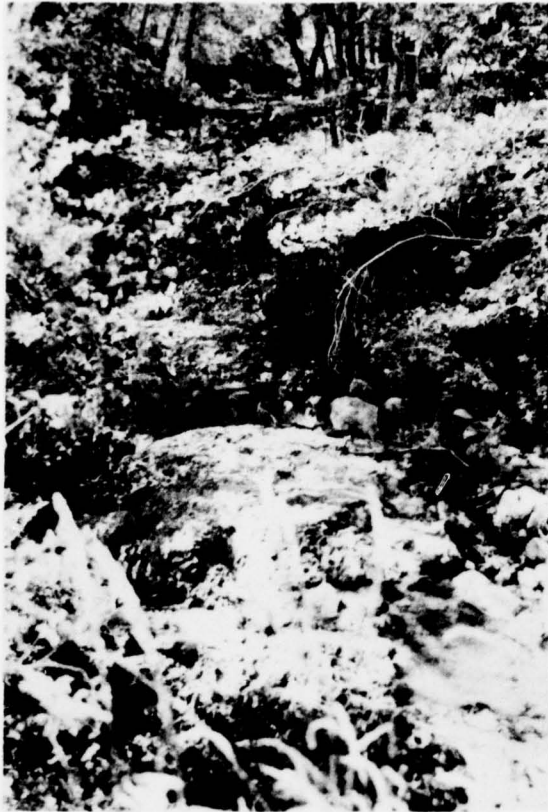
Photo 9 - Discharge channel from
spillway outlet.

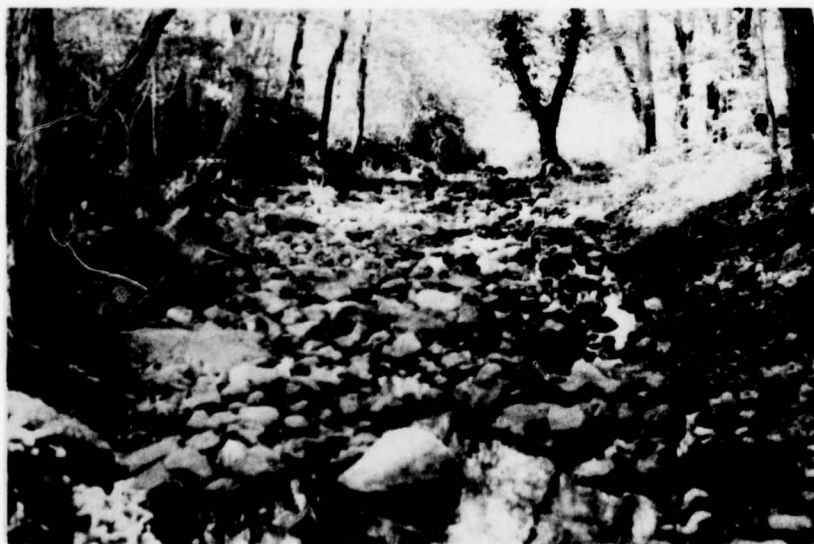
The downstream channel is well defined, free of vegetation and protected by numerous cobbles and boulders. The side slopes vary from steep to moderate and support trees and brush. Only minor erosion could be observed in a few areas.

Photo 10 - Downstream channel to lower impoundment.
